- OXYDATION OF ANODISED ALUMINIUM -

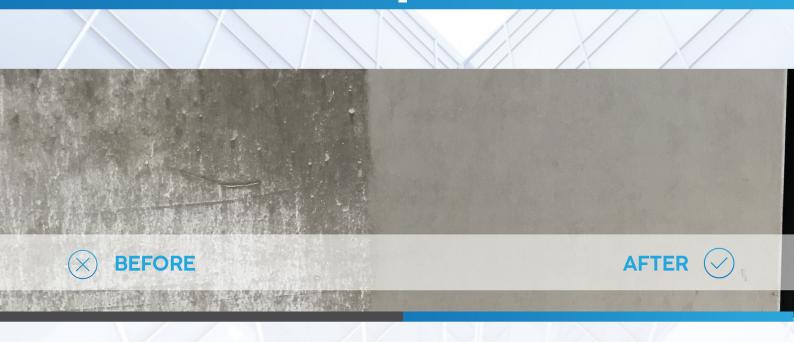
Anodised aluminium also shows signs of aging by fading and oxidisation. Fillers used to clog anodic coating during electrolyse tend to deteriorate with time and expose mill aluminium underneath it. Exposed to weather condition this aluminium will oxidise.

RENUGLASS is using PH Neutral product to clean up the aluminium and a special coating to clog back the pores and protect the anodic coating.

Solution: RENU-ALU "A" + PRO-ALU

Restoration of anodised aluminium is a 2 step action:

RENU-ALU "A" will remove corrosion and stubborn stains from the anodised aluminium

PRO-ALU coating will be applied on the prepared surface, giving it back its orignal shine and protecting it from further degradation
